# TORIN INC. – VEHICLE LIFT IMPROVEMENTS

DATE: 20221114

Torin Item: T9000-4ST

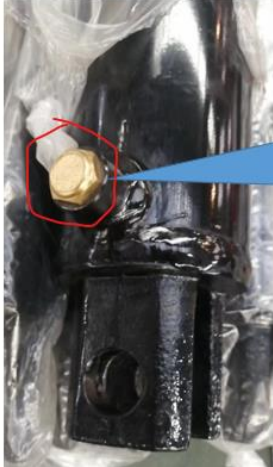
| CURRENT | IMPROVEMENT |
|---|---|
| <p data-bbox="406 378 592 556">There is a muffler at the air bleed hole on the cylinder</p> | <p data-bbox="644 350 1456 413">Torin improvement to the 4 post lift by adding a hose to prevent the cylinder from corrosion and debris getting into the hydraulic system</p> |

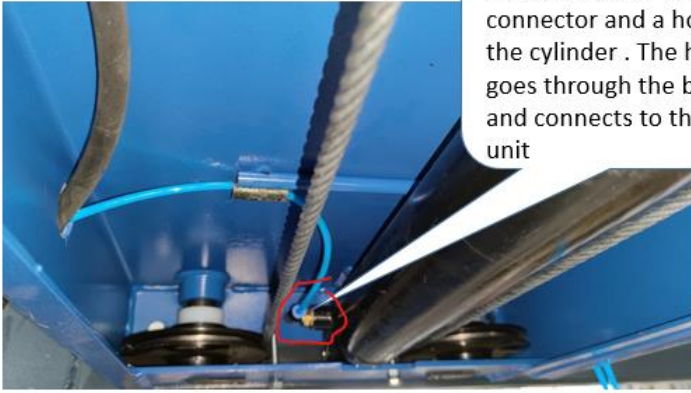
| CURRENT | IMPROVEMENT |
|---|---|
| | <p data-bbox="1144 934 1445 1144">Remove the muffler at the air bleed hole, add a connector and a hose on the cylinder. The hose goes through the bridges and connects to the power unit</p> |

| CURRENT | IMPROVEMENT |
|---|---|
| | <p data-bbox="670 720 906 846">Add two connectors, one on the cylinder and one on the power unit</p> |

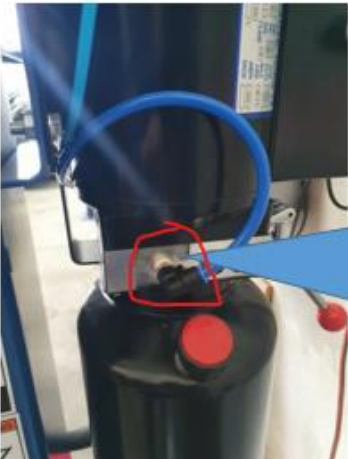
| CURRENT | IMPROVEMENT |
|---|---|
| | <p data-bbox="1023 1438 1274 1753">The hose goes from the cylinder and connects to the oil return hole on the power unit</p> |
